***Report No. UT-03.34***

***FLEXURAL PERFORMANCE OF  
RETROFITTED REINFORCED  
CONCRETE CANTILEVERED  
BENT CAPS – PART 2***

**Utah Department of Transportation  
Research Division**

**December 2003**

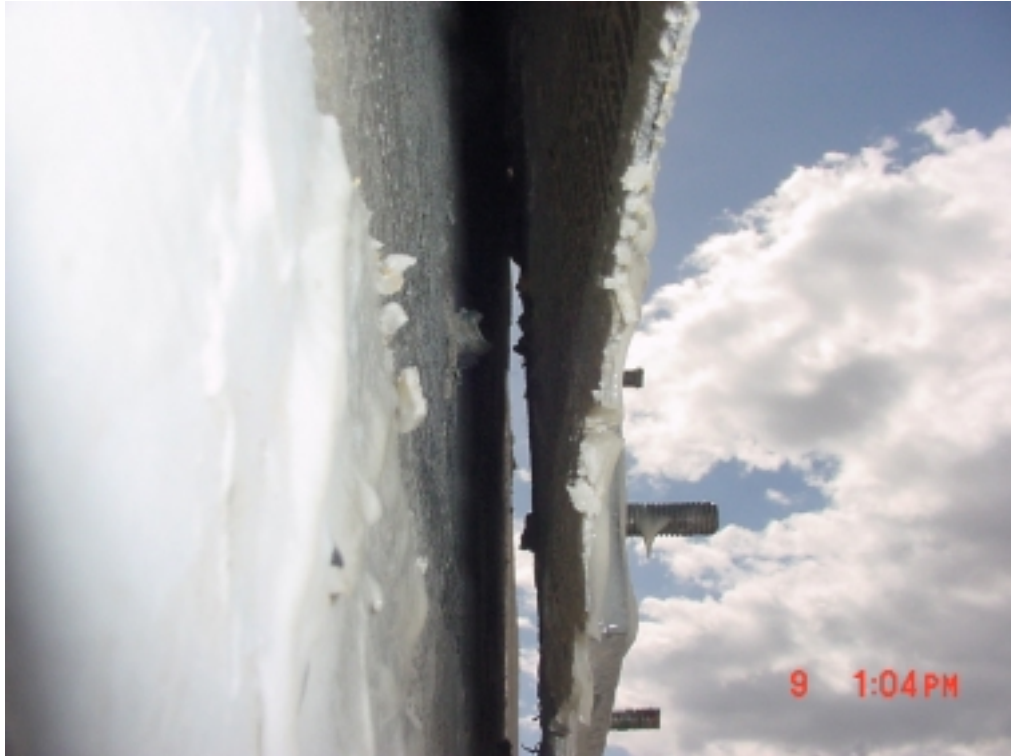
damage to the instrumentation. Figure 4.125 shows the condition of the FRP wrap after testing. An inspection of the steel anchoring system indicated that most of the steel bolts had sheared off (Figure 4.126).

Figure 4.126 – Bent 13N, sheared bolts of the anchorage system
